# FACILITY COMPLIANCE INSPECTION REPORT

## Division of Waste Management Solid Waste Section

**Date of Site Inspection:** 23 August 2011      **Date of Last Inspection:** 3 May 2011

Carteret County Closed MSW Landfill  
Landfill Road  
Newport, NC

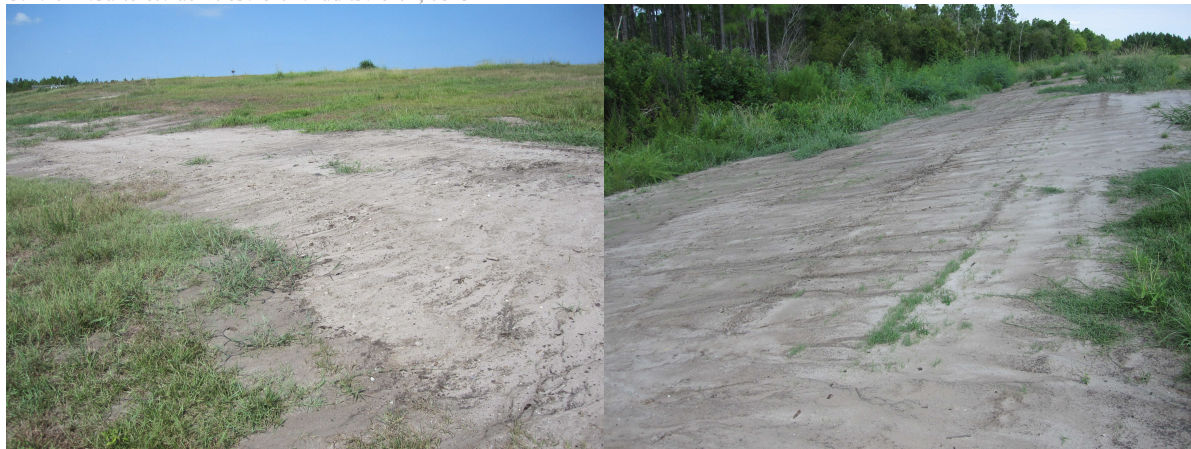
- 8) Areas of erosion were noted at various places throughout the landfill sideslopes. Repairs including filling and grading are currently underway. \*Please continue working to repair these eroded areas with continued grading, seeding, and mulching as necessary to establish a groundcover suitable to prevent erosion of your landfill cap system. All repaired

Recently repaired areas filled and graded in need of seeding and mulching

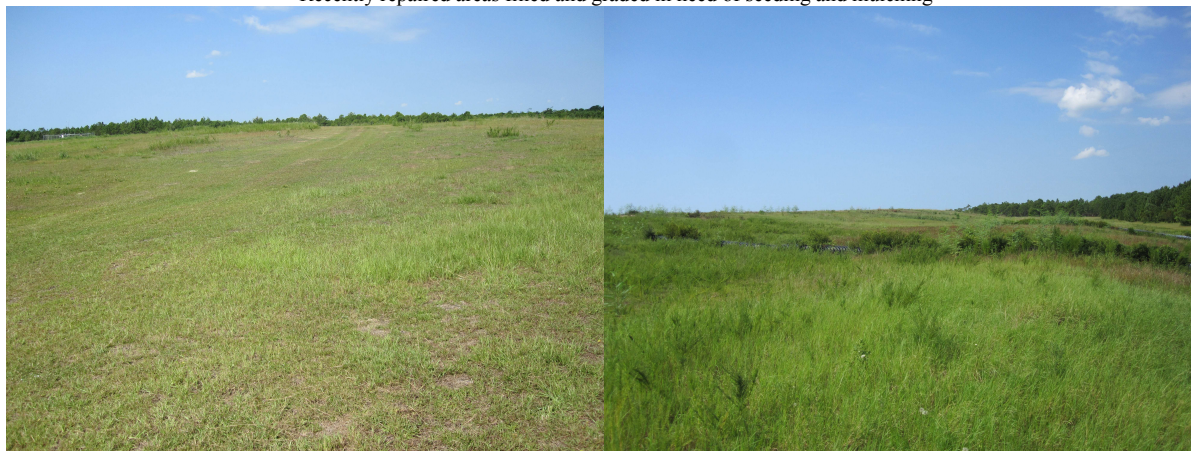
Overall well established cover crop of native warm season grasses

Surface water drains from top lift of landfill
